GREAT NEAPOLITAN EARTHQUAKE OF 1857.

OBSERVATIONAL SEISMOLOGY

TO INVESTIGATE THE CIRCUMSTANCES OF THE GREAT
EARTHQUAKE OF DECEMBER 1857.

ROBERT MALLET, C.E., F.R.S., F.G.S., M.R.I.A.,
&c., &c.

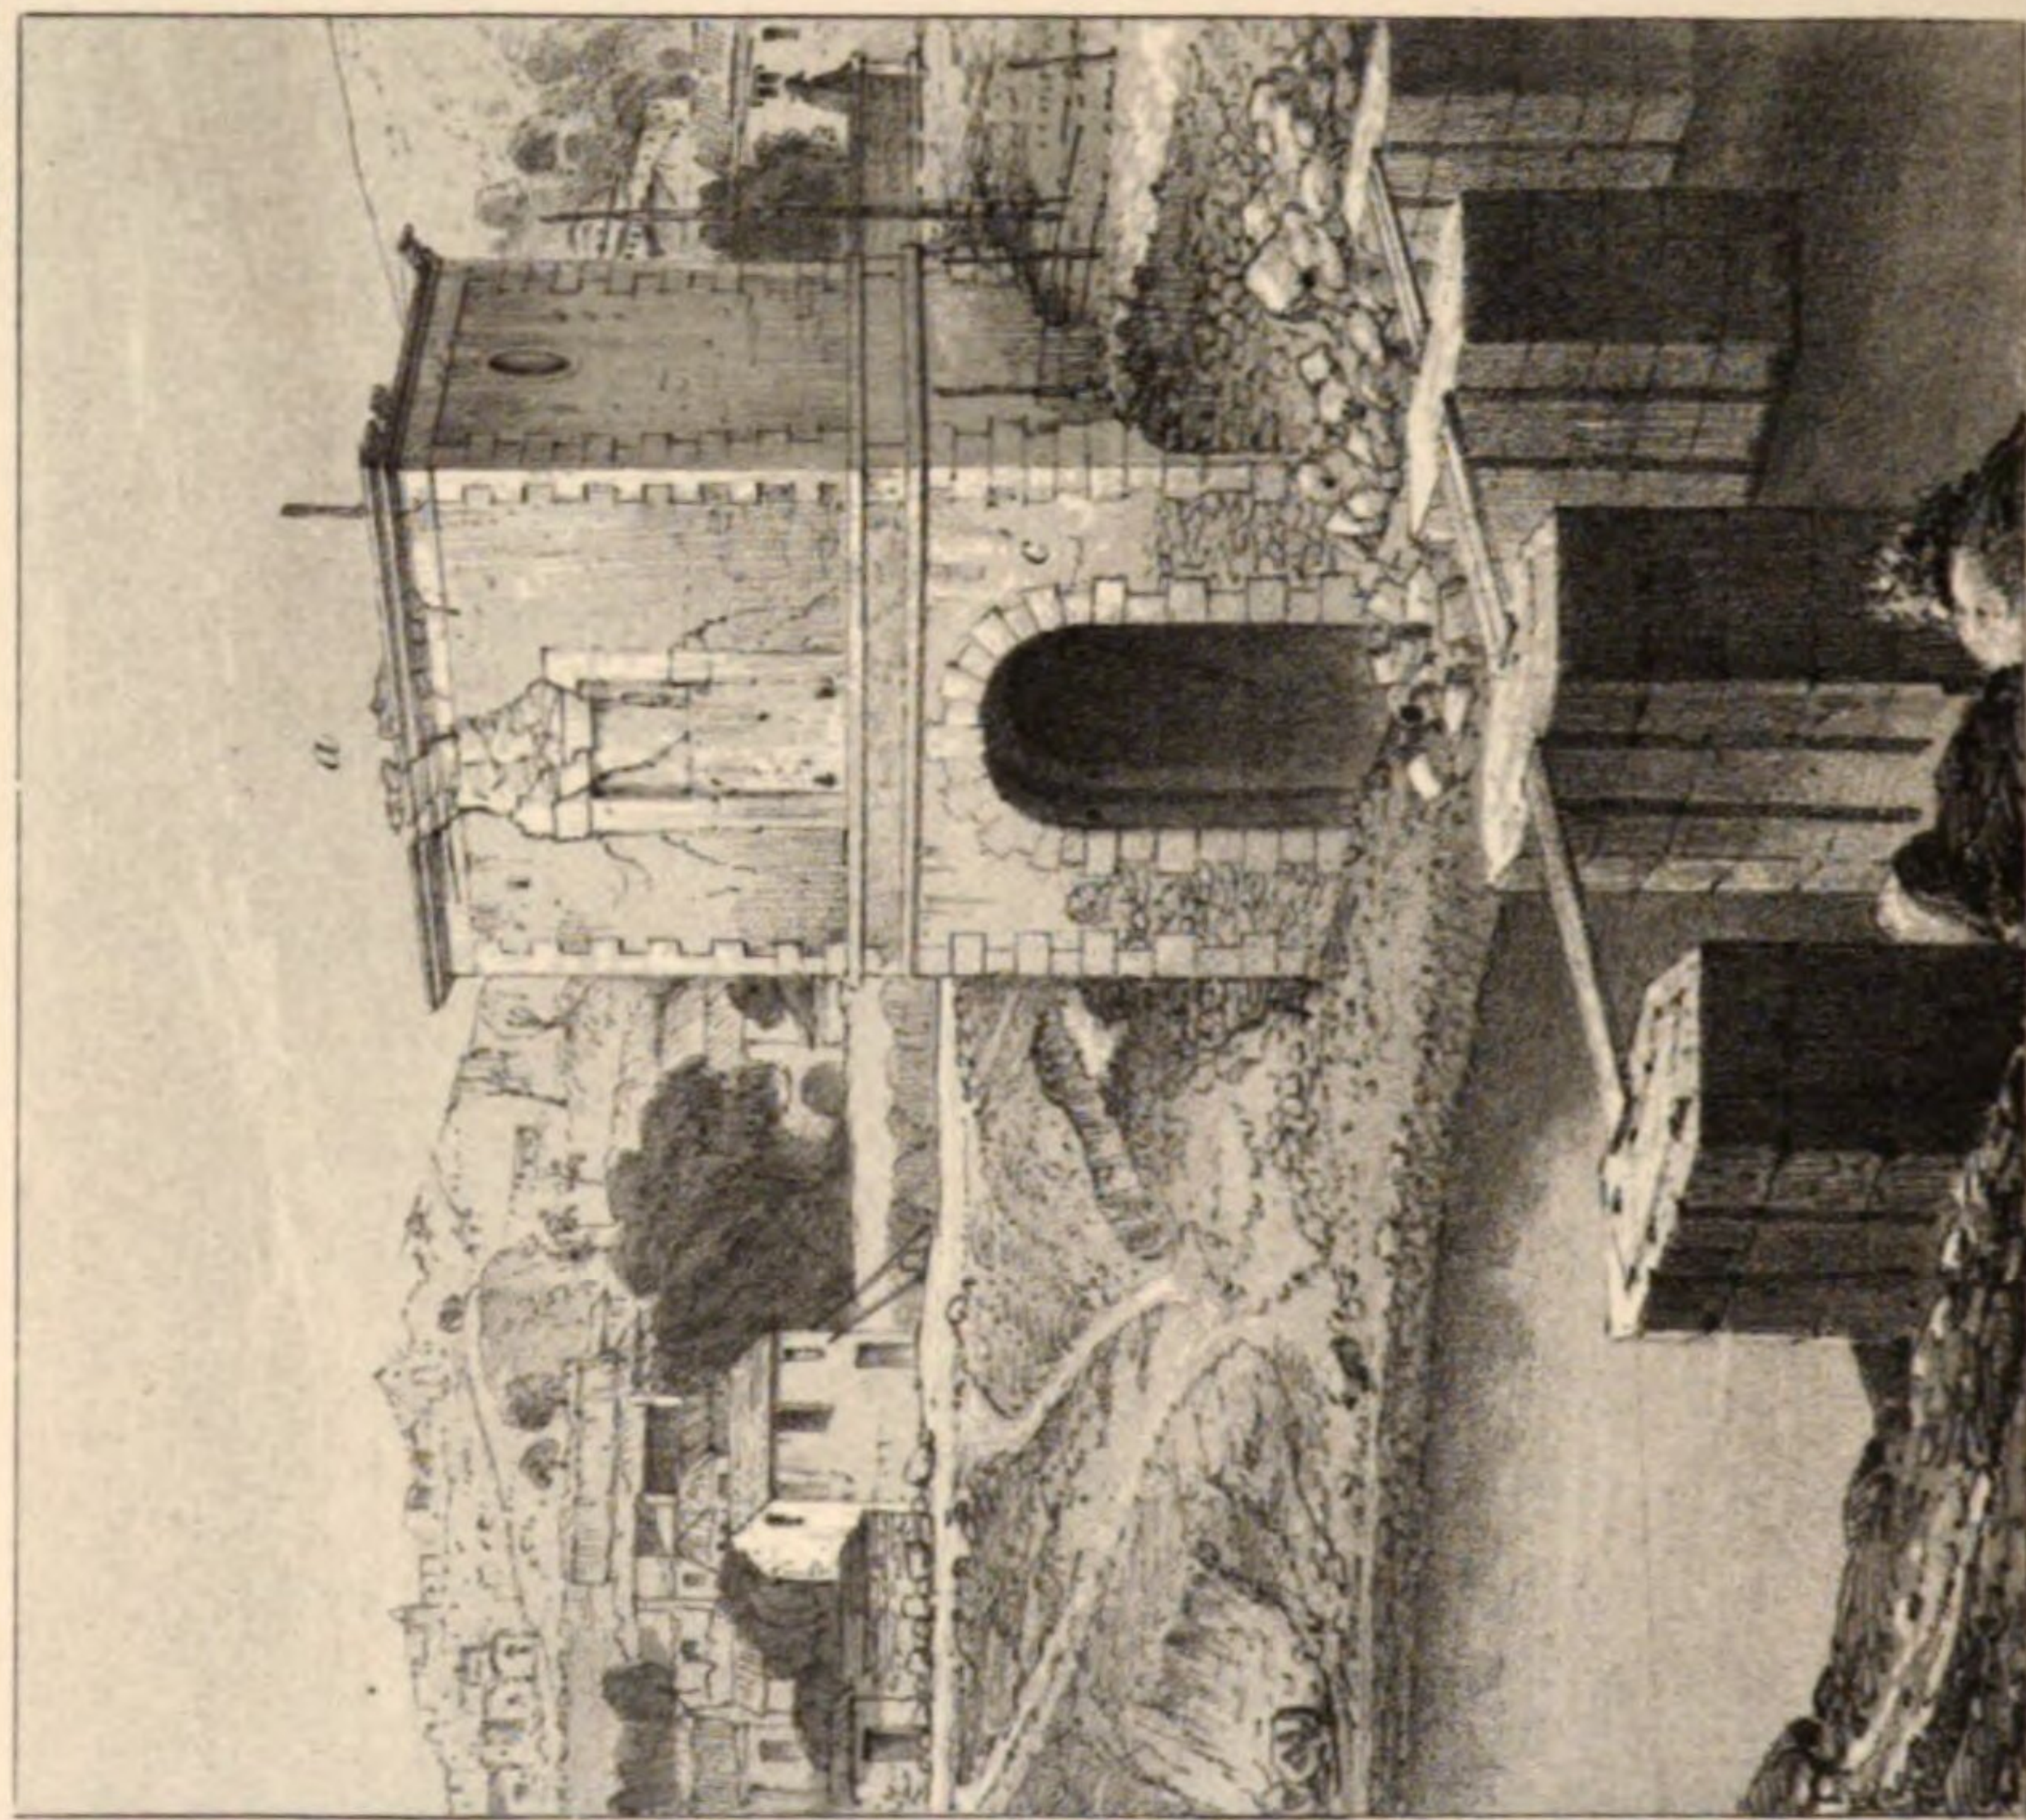
Photo. Pl. 173.

SMALL HOUSE BY THE RIVER. POLLA,
looking Westward.

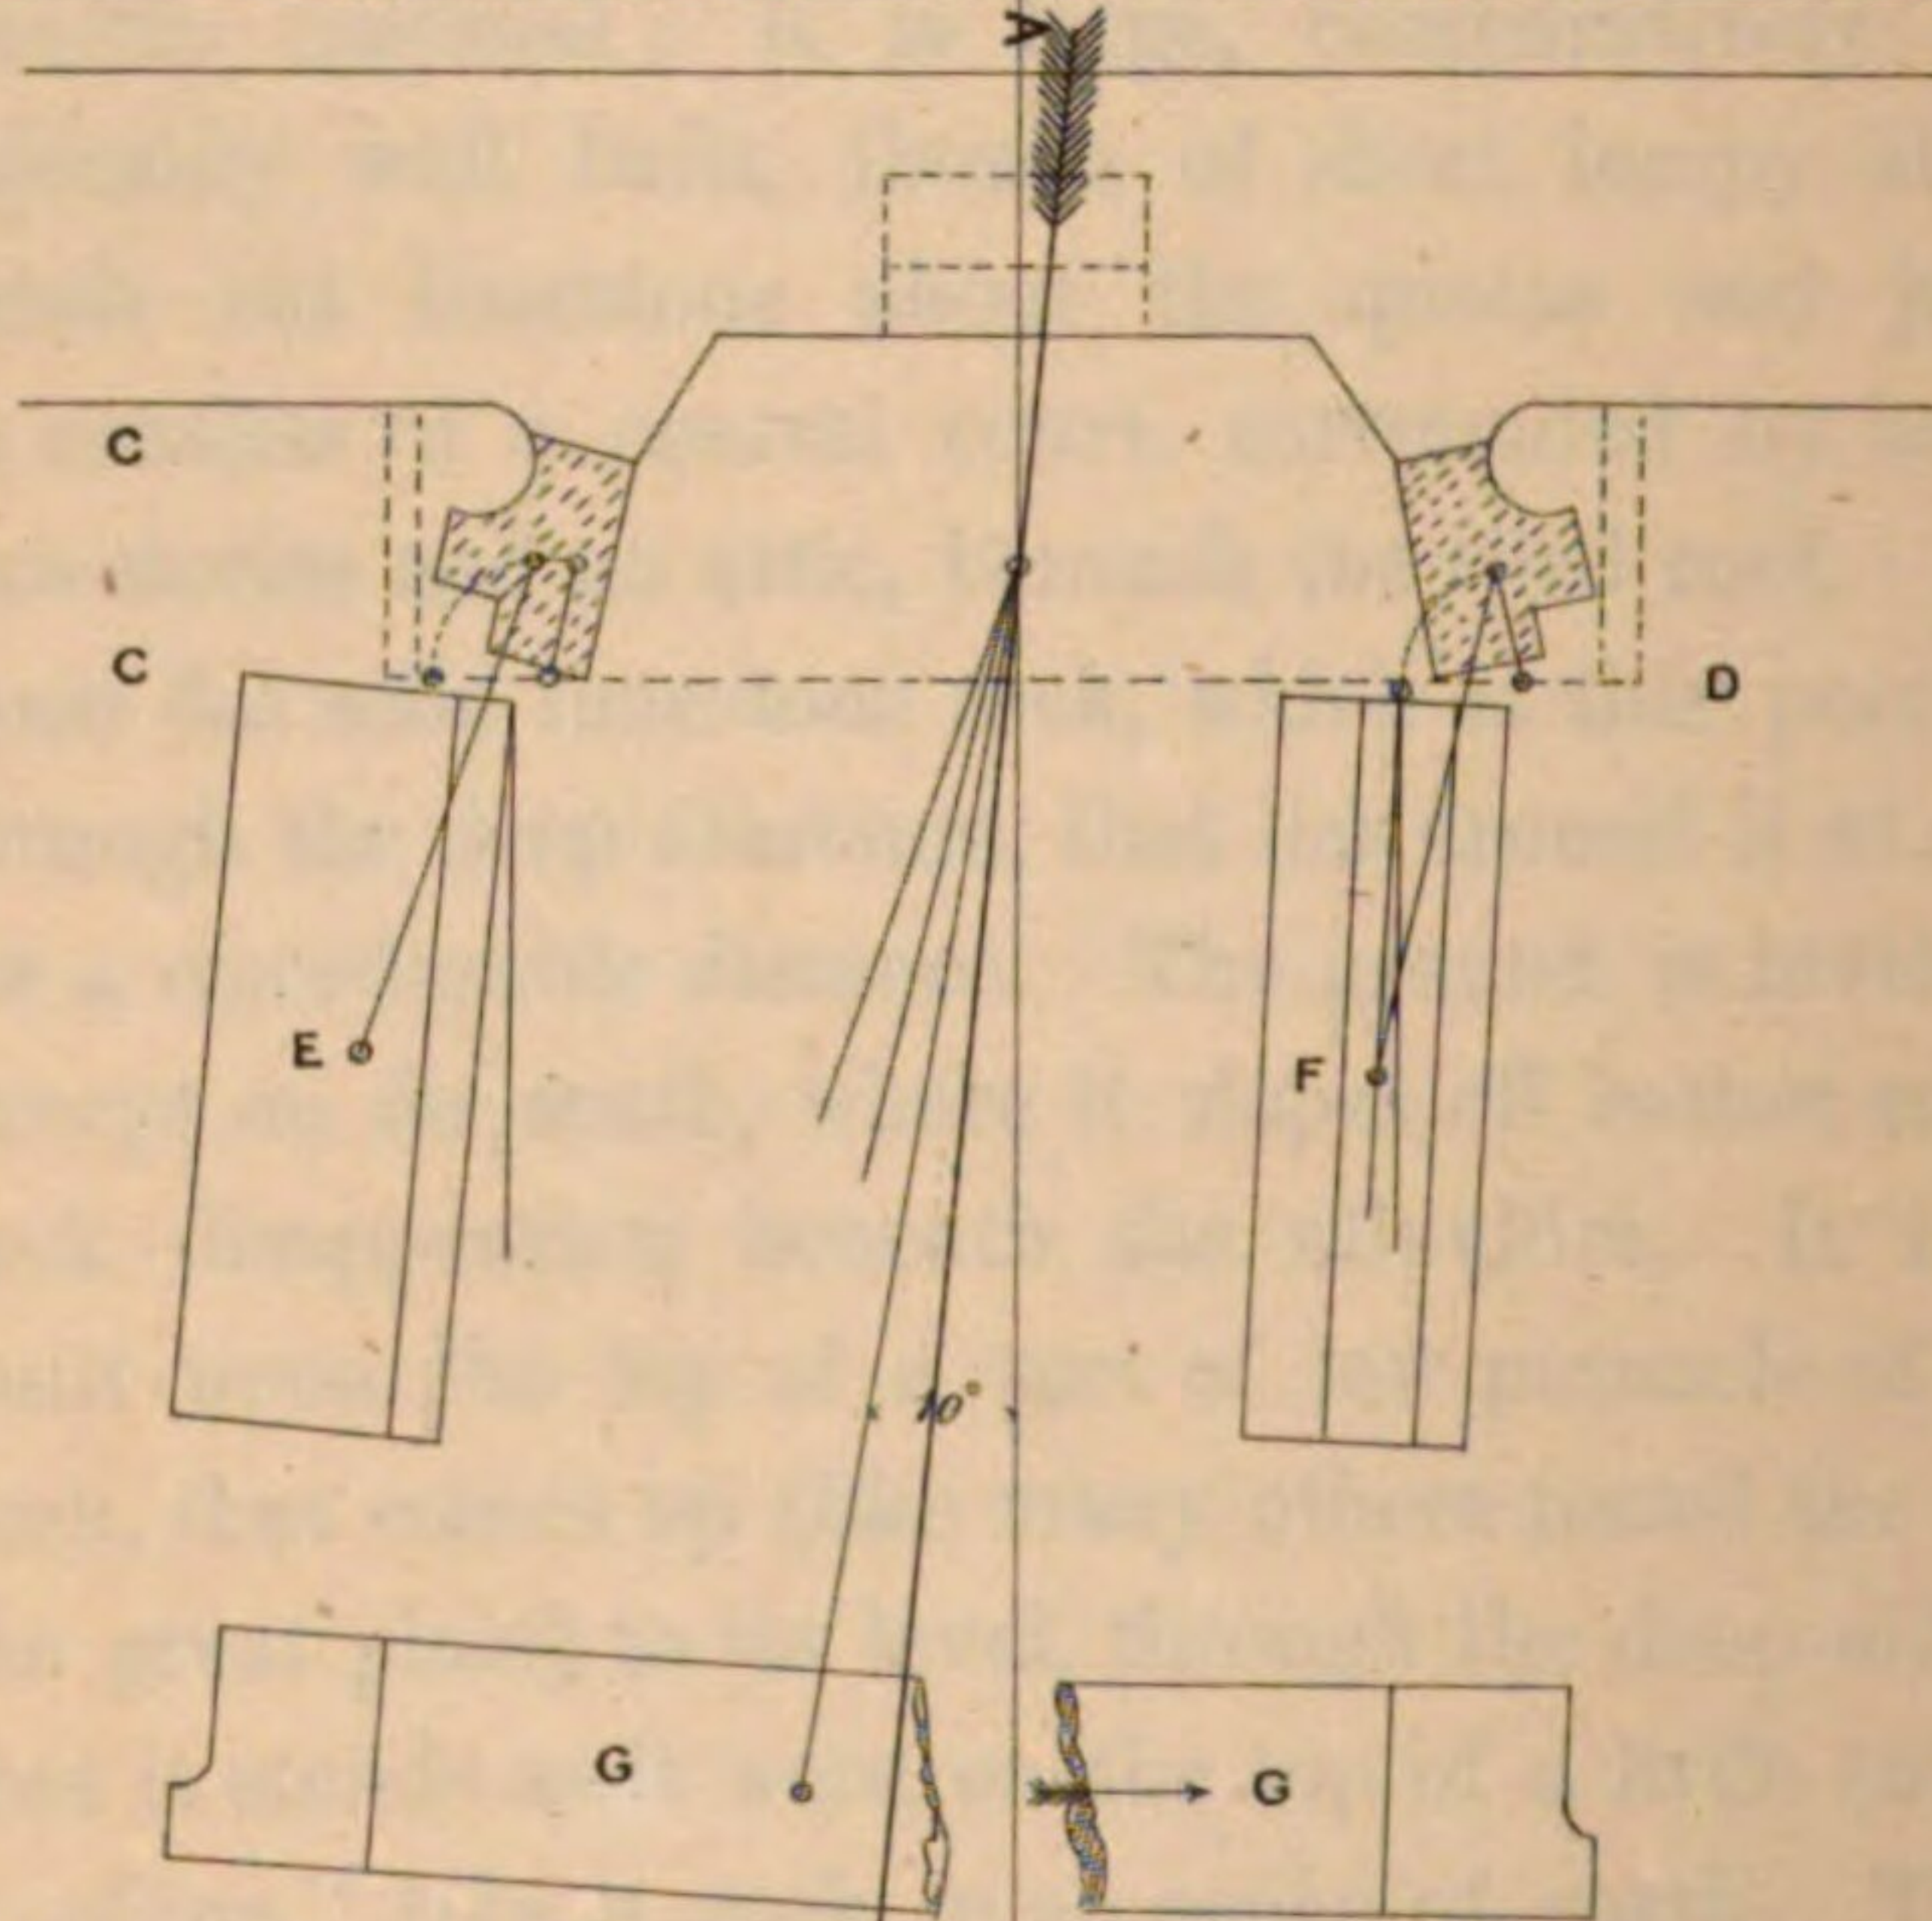
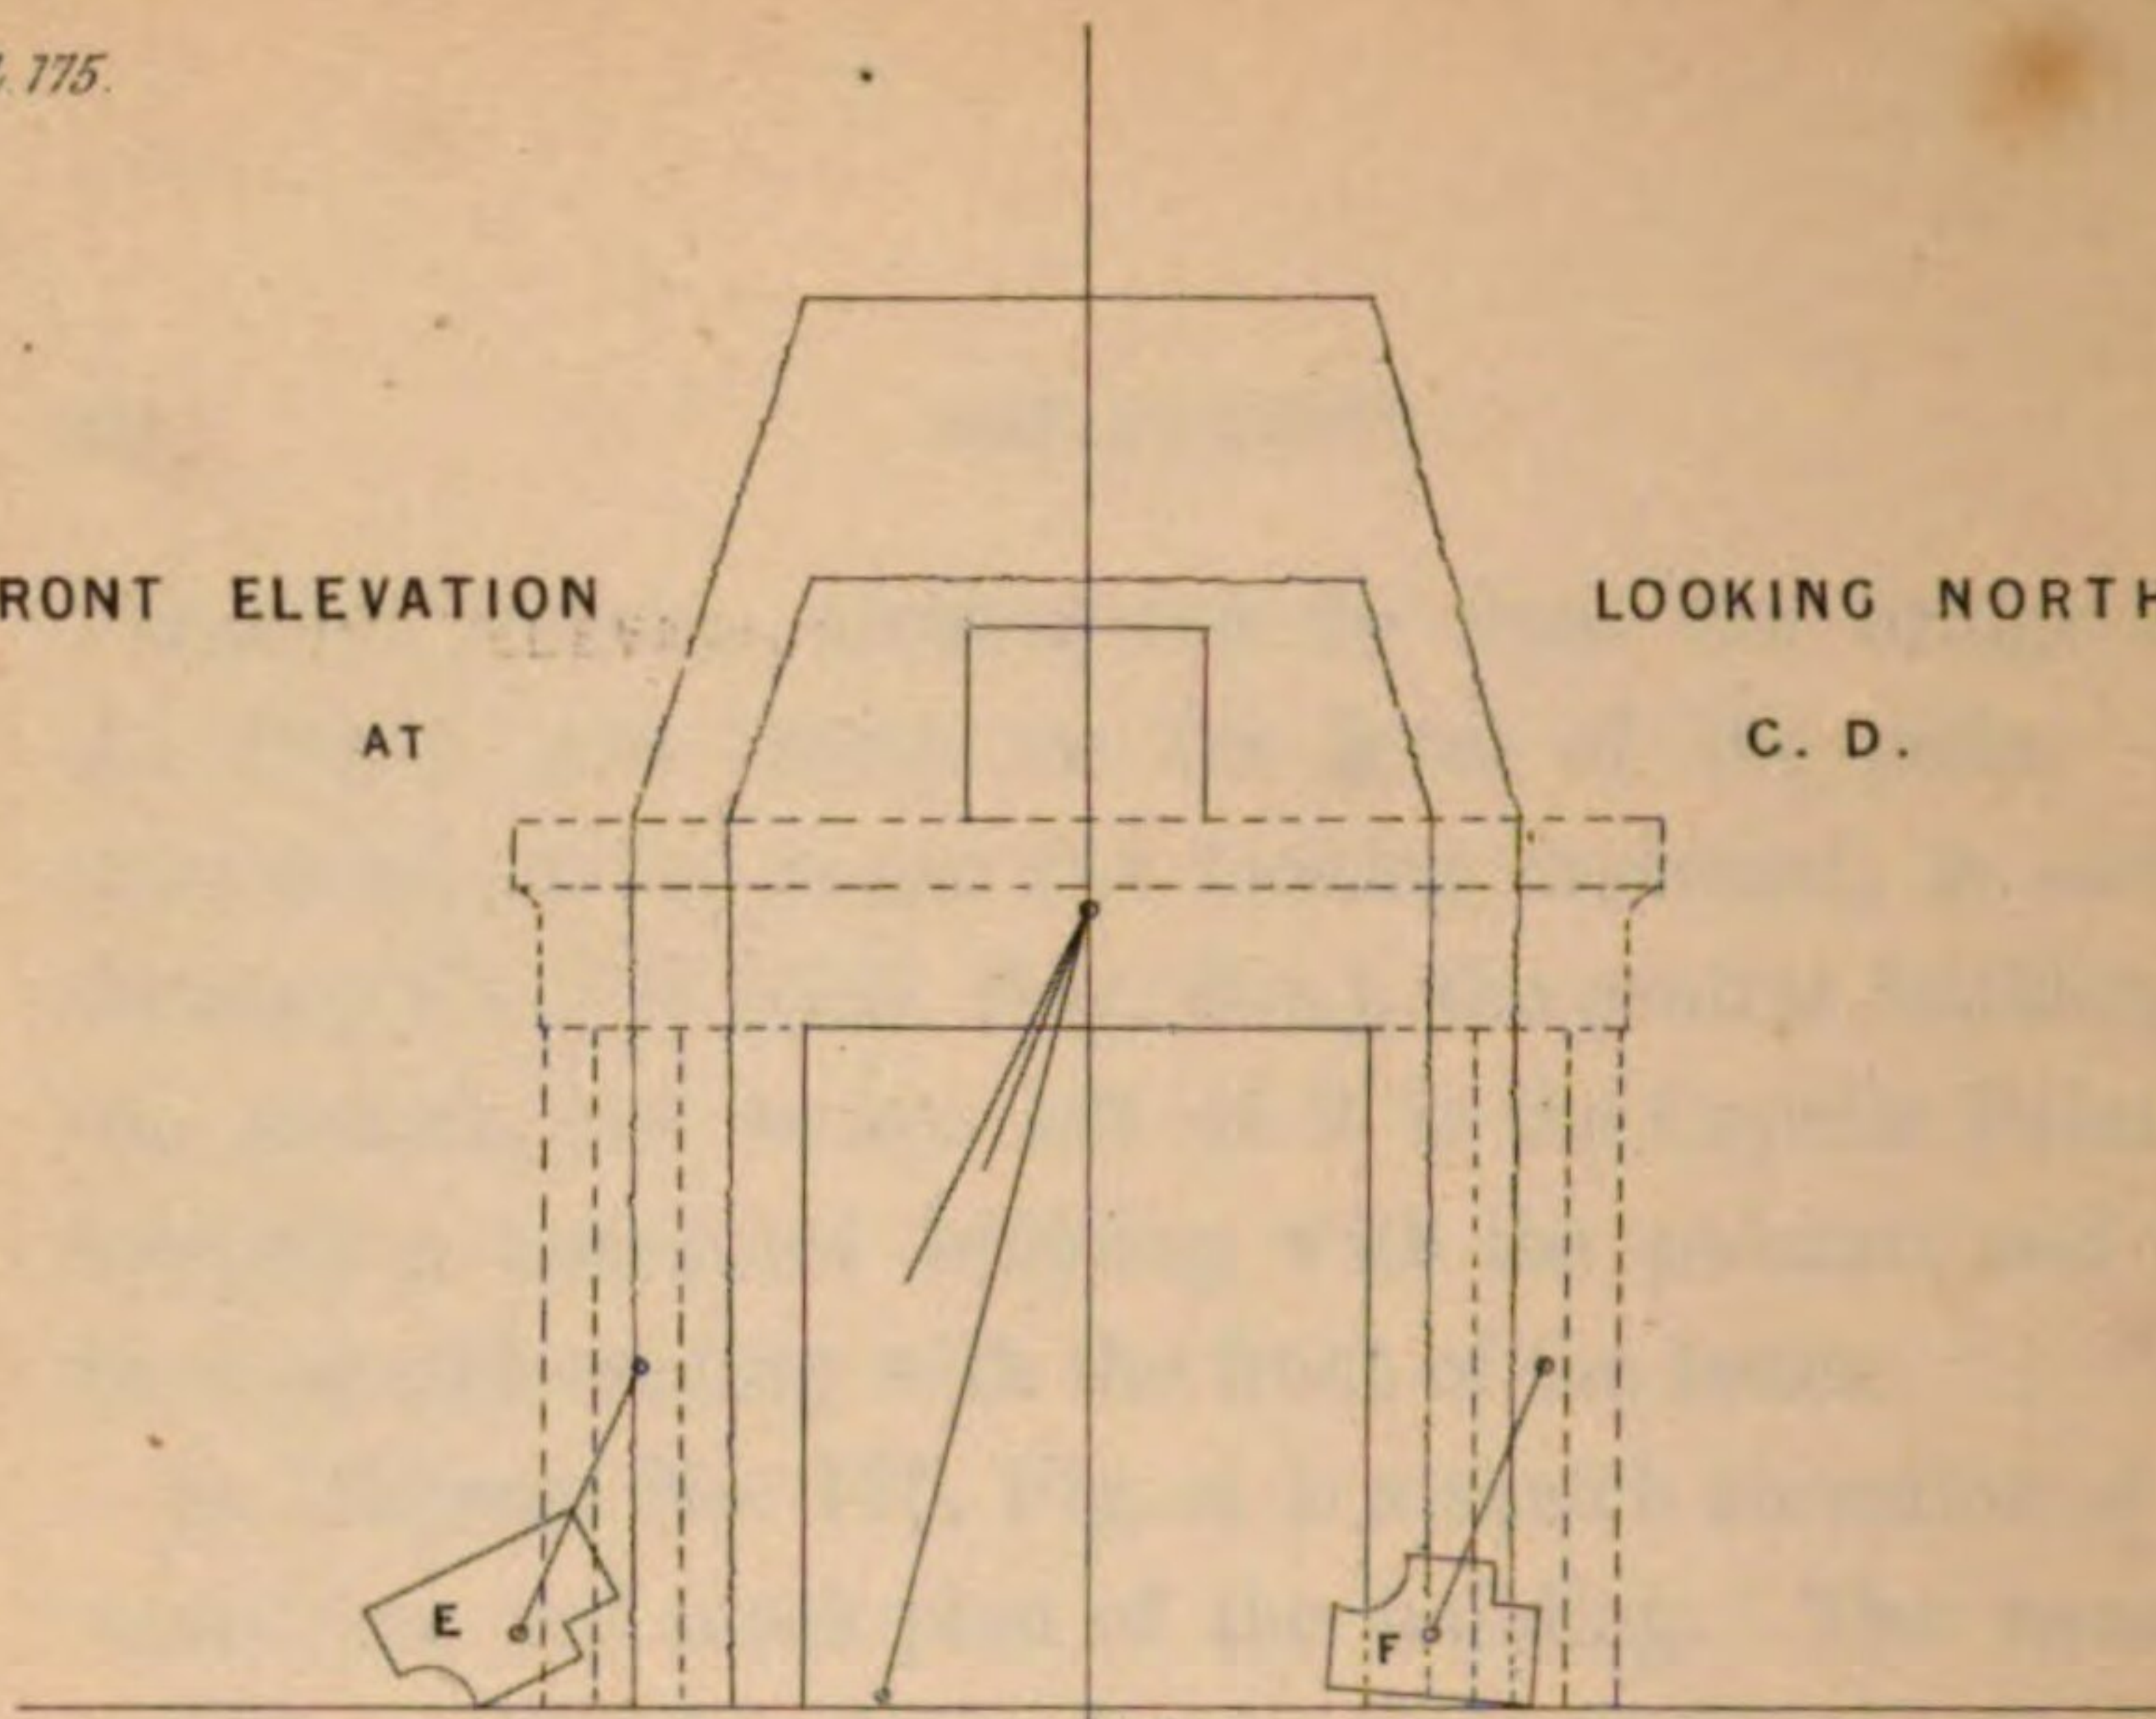
In Diagram No. 175, Fig. *a*, is a sketch elevation of this west front and block plan of the building. The house is exactly cardinal; it is large, comparatively new, and tolerably well built, though of short lumpy stone, with much cut limestone about the quoins and jambs, &c. It consists of a central court, surrounded by buildings of two stories and an attic, beneath the tiled roof. It is built upon the solid limestone rock, which at this point rises up through the deep alluvium, that lies around it at every side for a considerable distance. The ground is level around it except on the south, where it slopes off rather rapidly, the rock disappearing beneath the alluvium. It is, in fact, built upon the top of a sort of low pinnacle of limestone rock, that comes up (like many others round the borders of the great plain) to its level, through the deep alluvium, so that it stands as it were on the top of a little subterranean "colline," like a rock in an ocean of earth. The beds of the limestone here, as generally throughout the Vallone, are almost vertical, or at extremely sharp dip, and tend to a general east and west direction of strike.

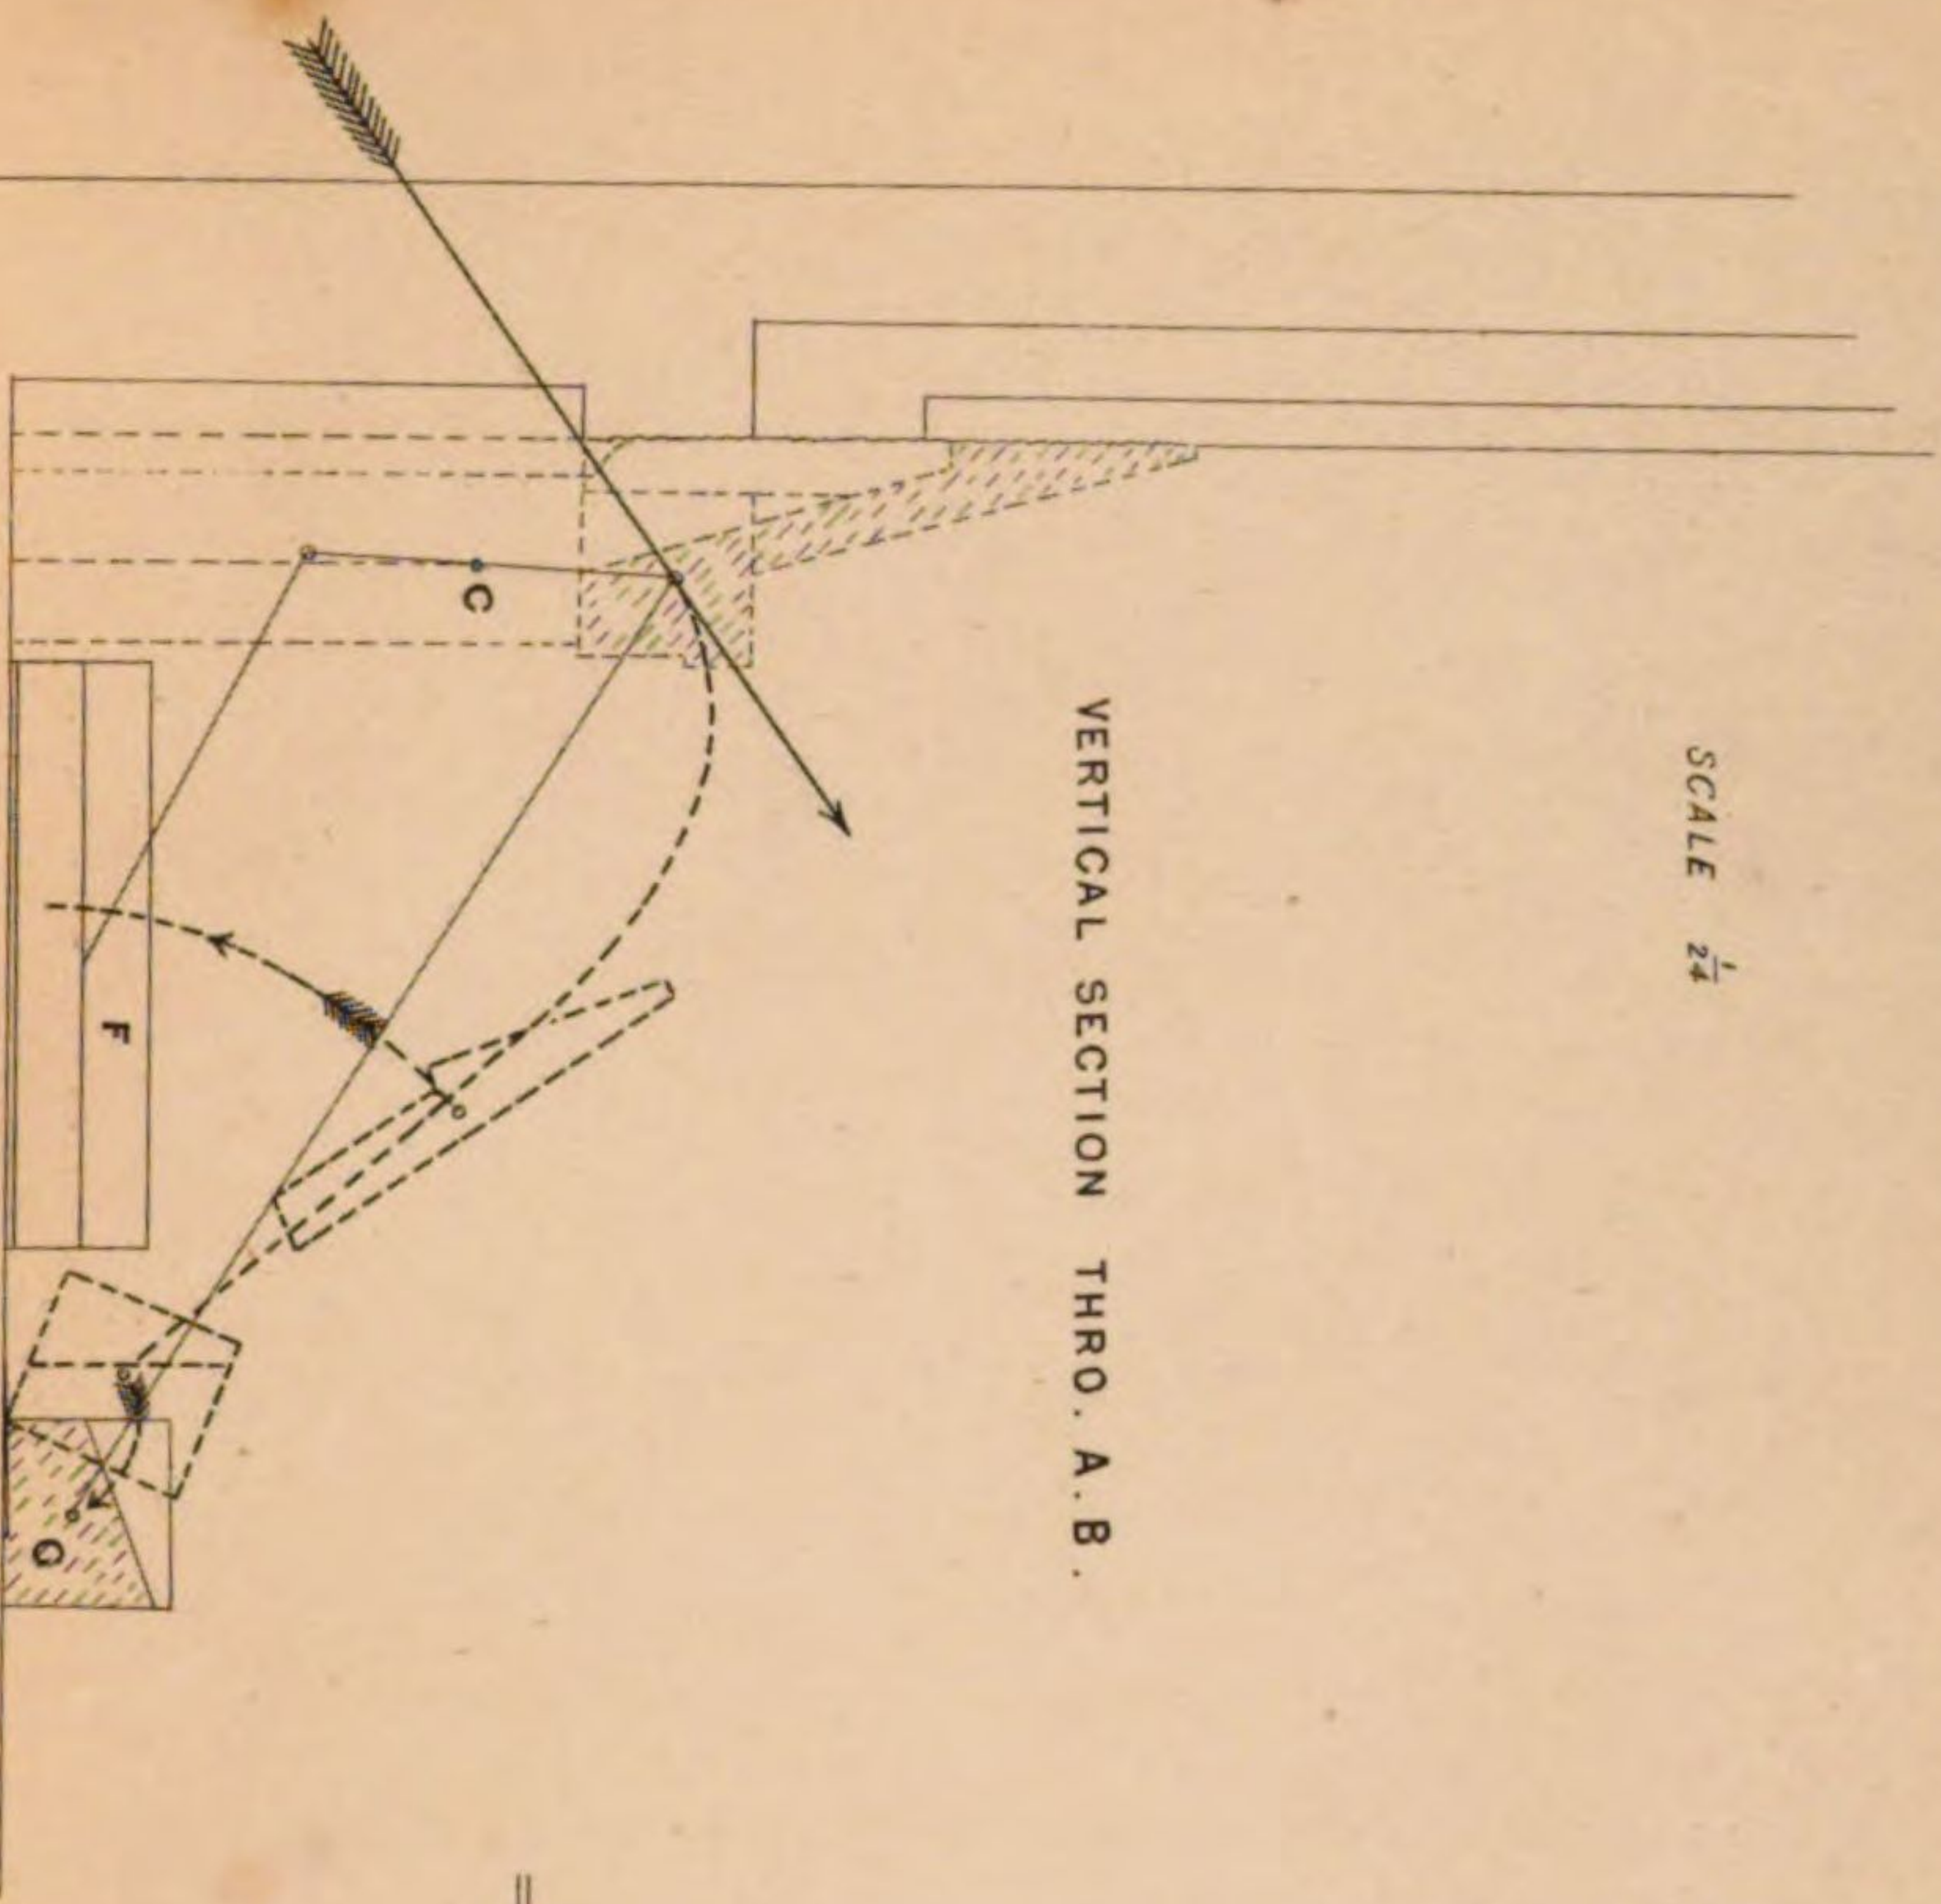
STONE BLOCKS OF THE CAMINE IN KITCHEN. AT
PALAZZO PALMIERI. THROWN FORWARD.

Fig *b*, 175 is the "camine," in front elevation, Fig. *b*, &c., 175 in ground plan, Fig. *b*, 175 in vertical mid section transverse to the line of wall. The dotted lines, show it as it stood before the earthquake, the hard lines representing the respective positions, in which I found the three blocks of stone lying, on the floor with the loose brick and plaster rubbish (chiefly) in the midst just as they had fallen; and Photog. No. 183 represents their appearance, and that of the wall from which they had been separated. The three blocks of stone merely *stood against*, the face of the chimney recess of the wall, and were made good to it with mortar, as was also the bit of pyramidal brickwork above the lintel. There was *no bonded connection between them*, nor any

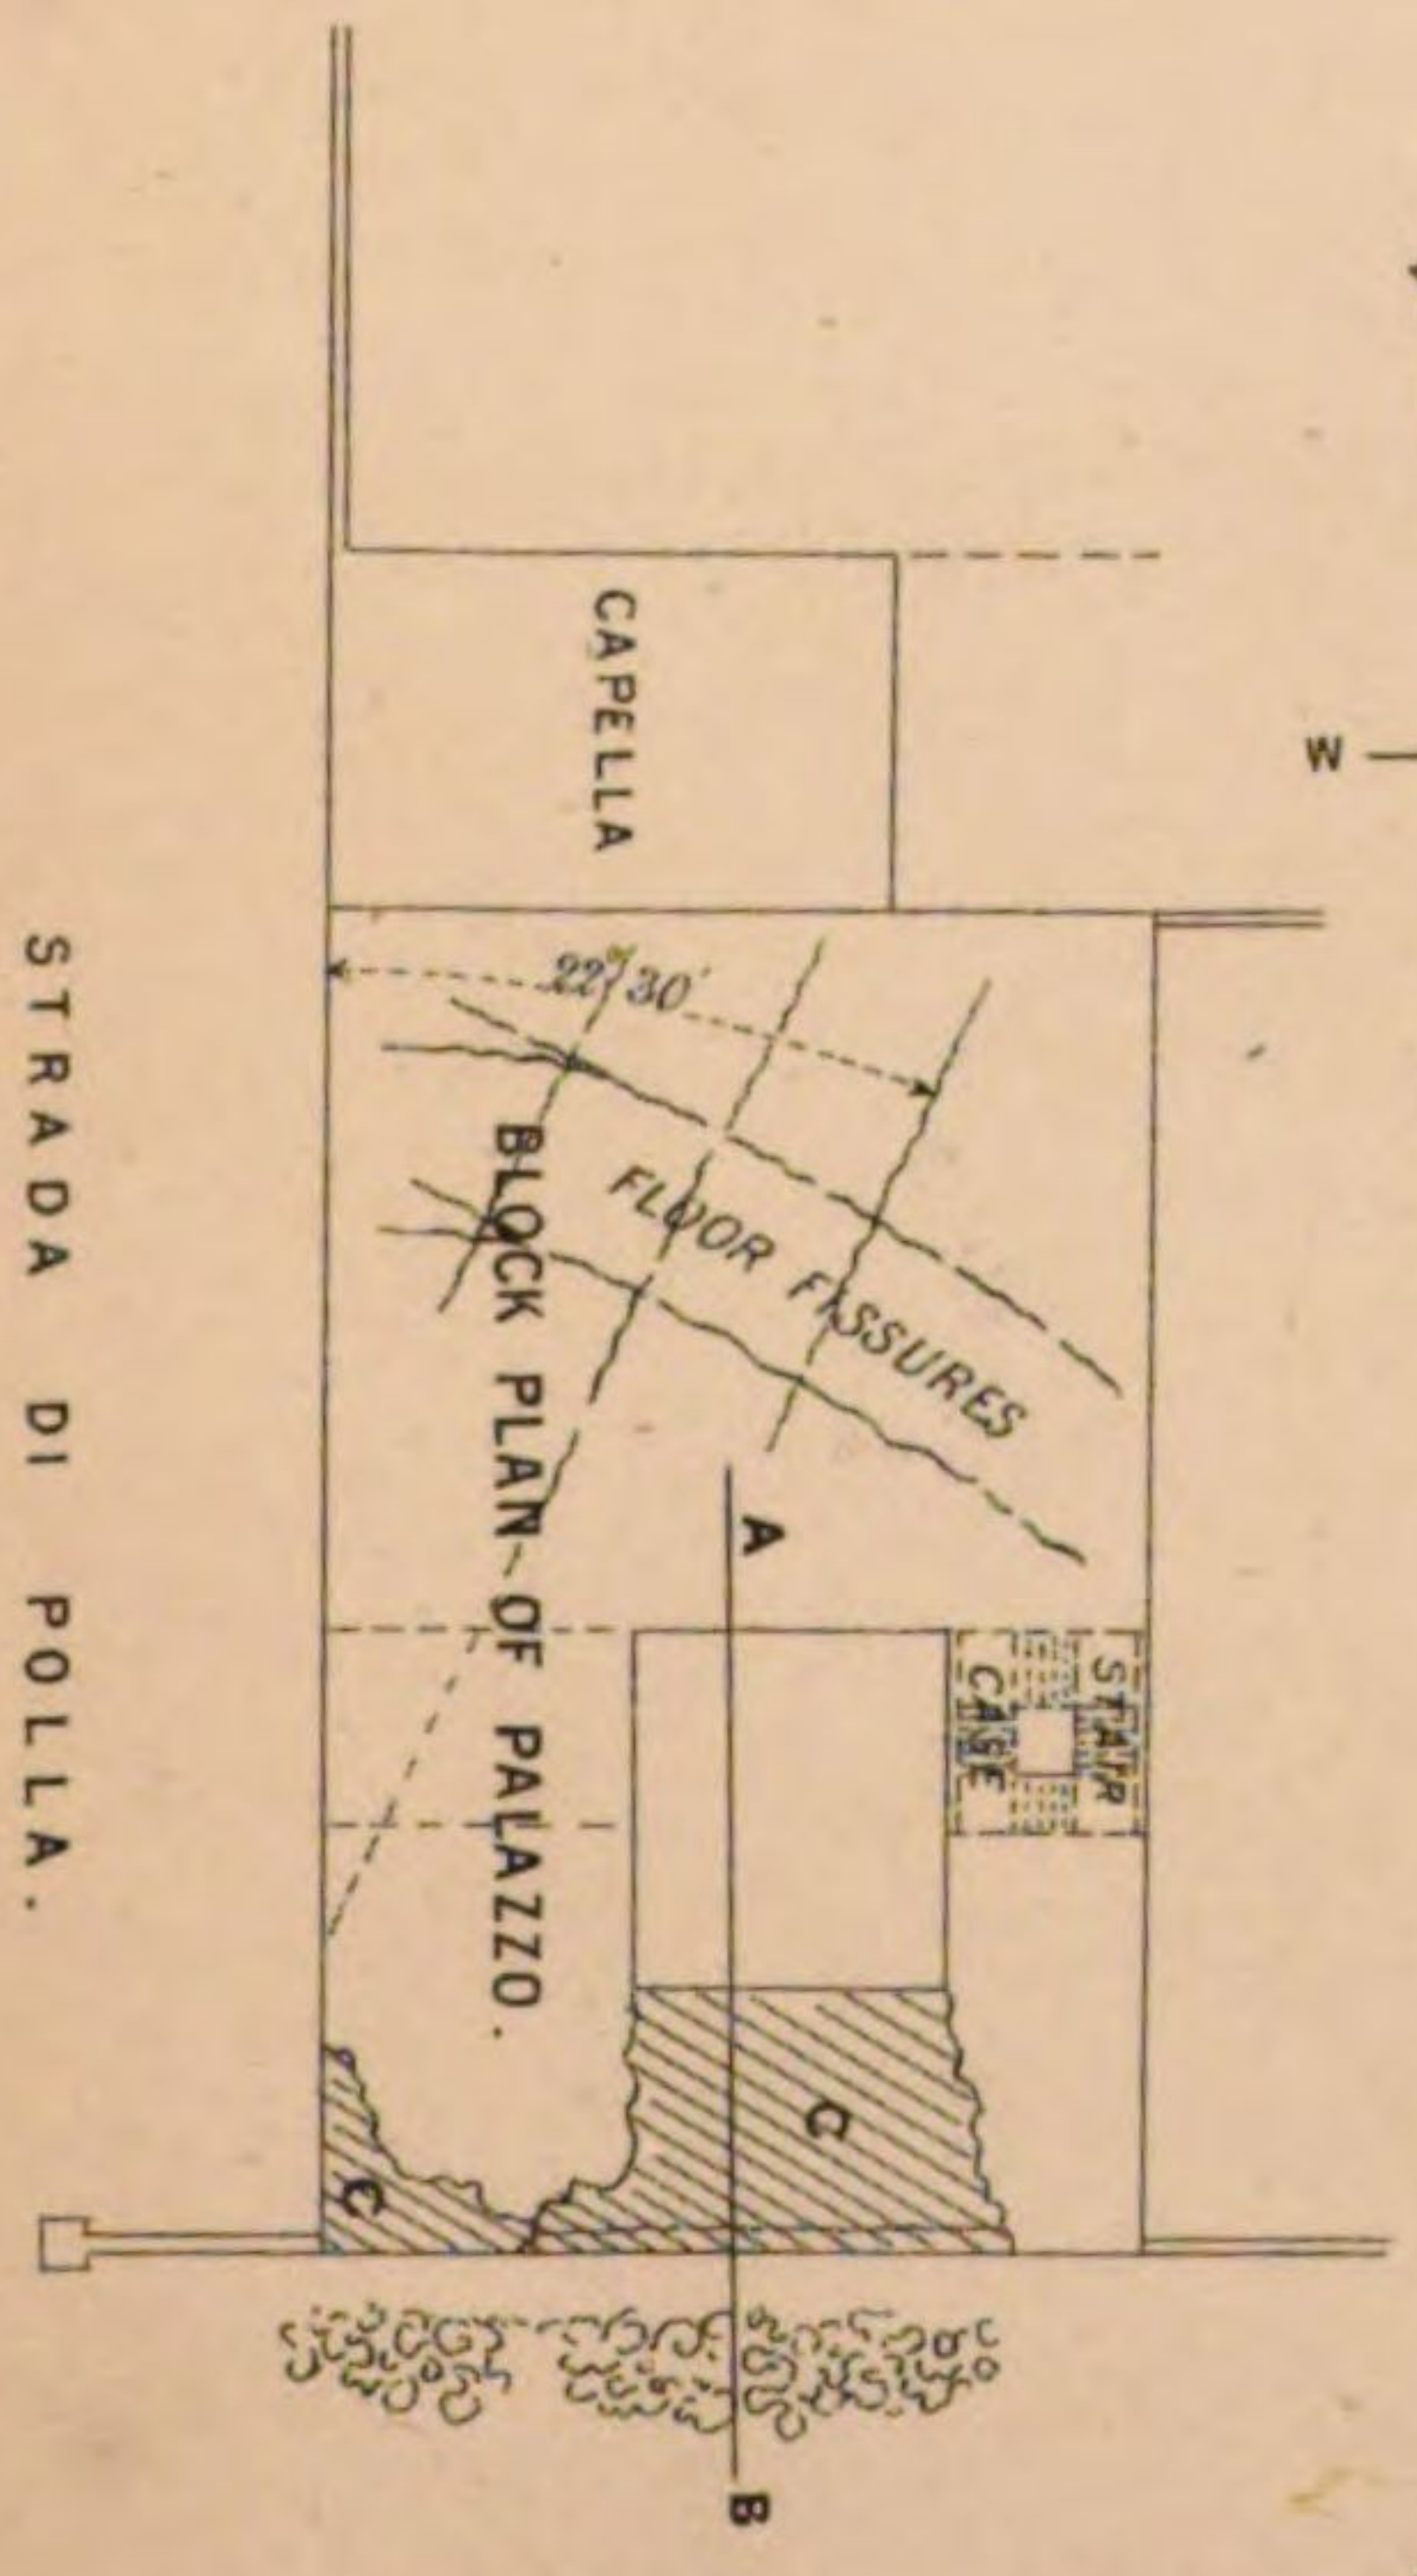
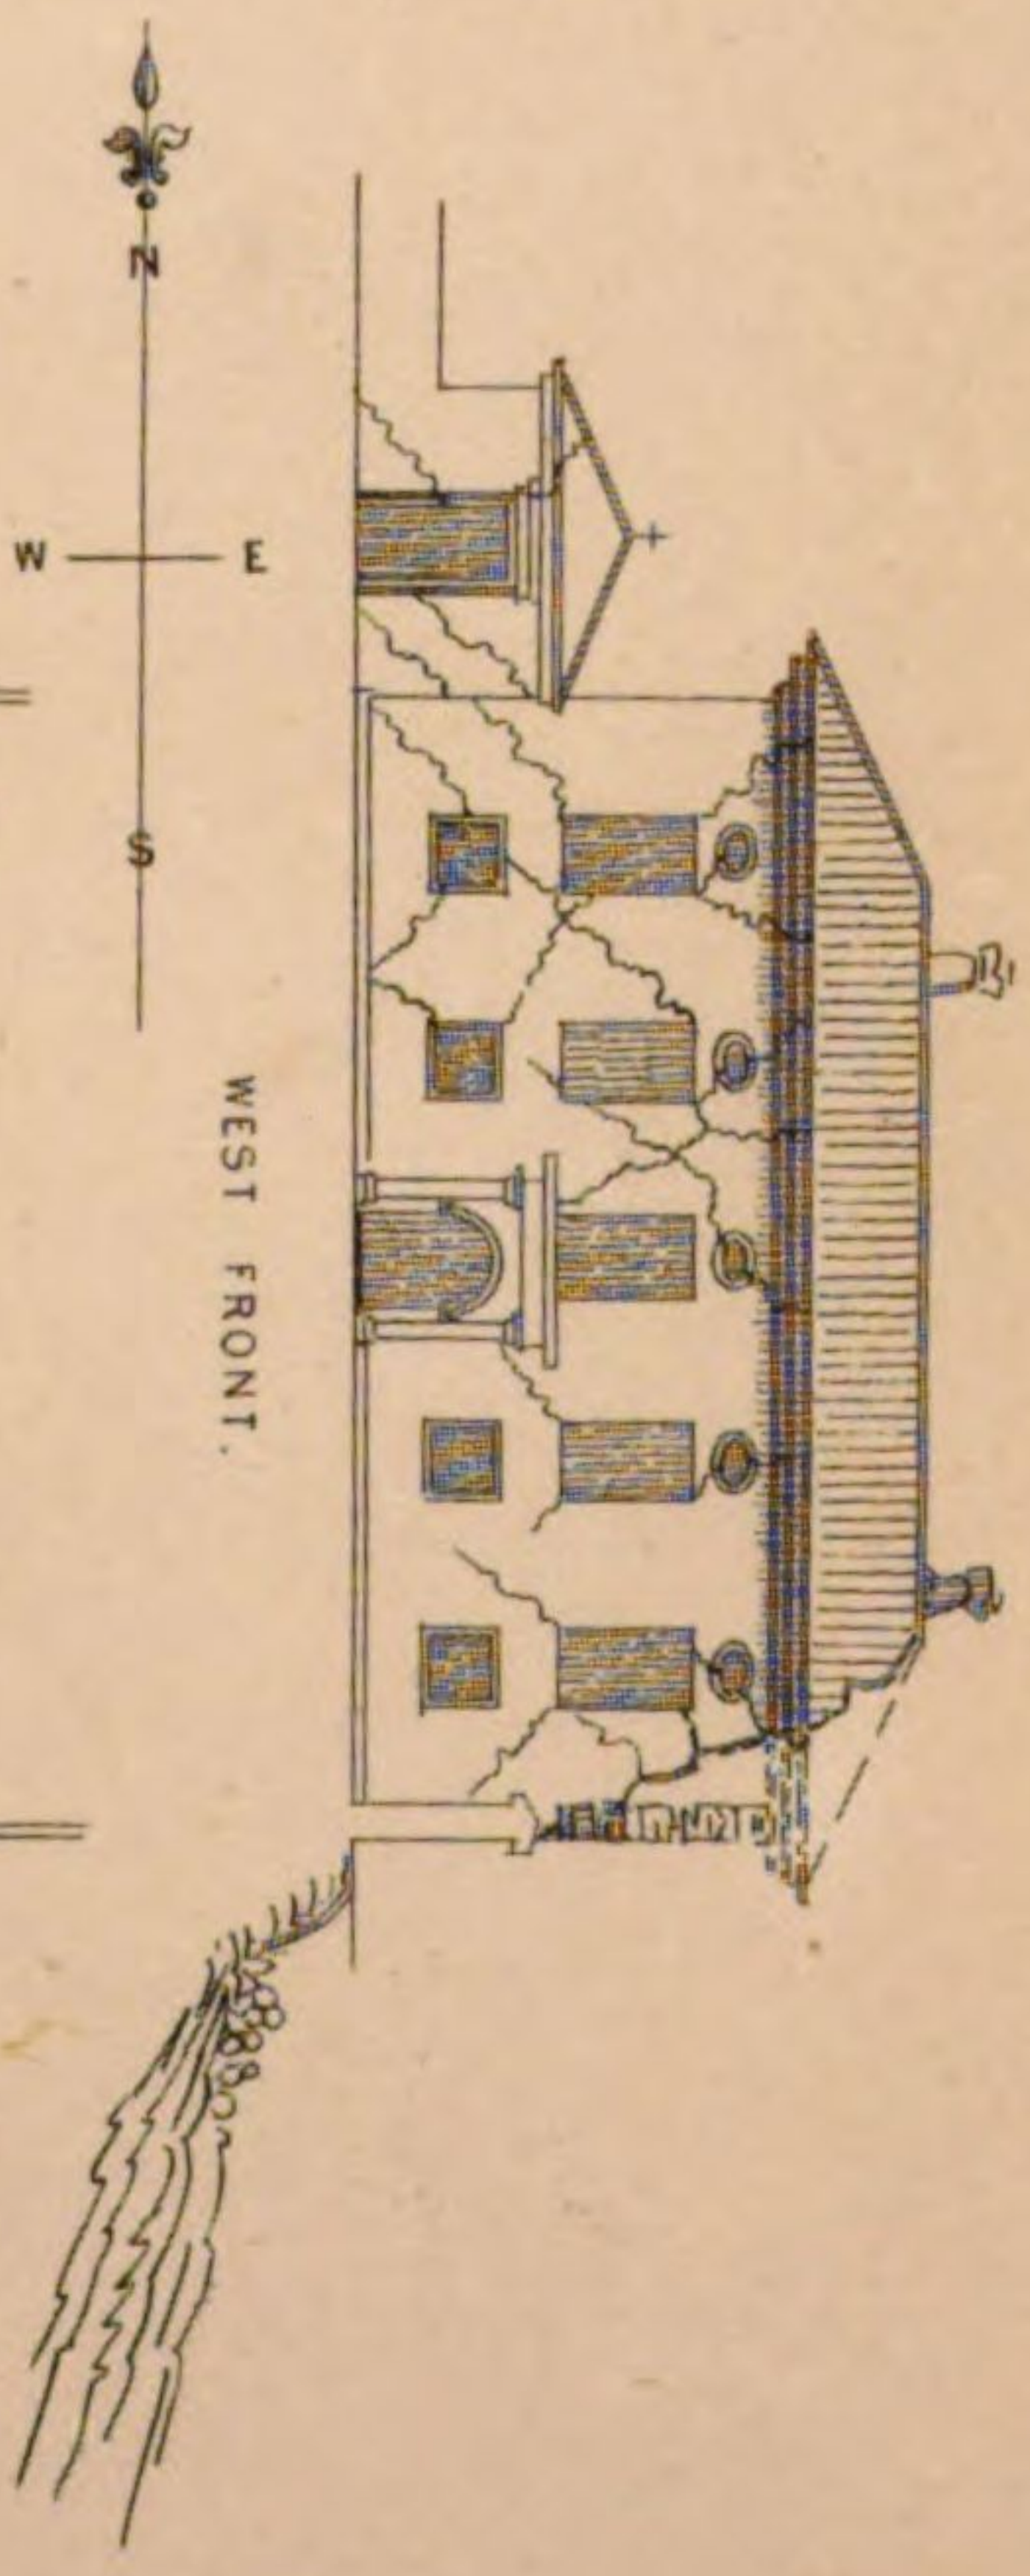
PALAZZO PALMIERI AT POLLA. SKETCH NOT TO SCALE.

C. C. PART PROSTRATED
THROWN SOUTH.
